**Flood Control Project Maintenance
Levee Inspections**
LMA District Cover Sheet
Spring 2017 Levee Inspection Results

Reclamation District No. 1001 Nicolaus

Unit Cover Sheet

Spring 2017 Levee Inspection Results

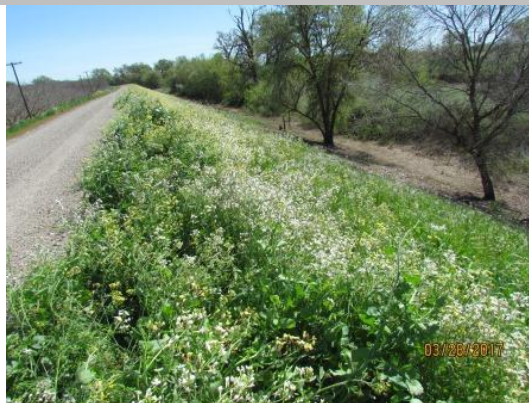
Photo 1 of 1 : SP_2017_RD1001_36_17_20170403_00022.jpg

LM Start	0.14	Rating **	U	Issue No.	17
LM End	3.83	Issue Type +	Ma	Location *	WS
Category	Earthen Levee			GPS Latitude/Longitude	
				Start	End
Item	Vegetation			38.978880 °	38.966766 °
				-121.471988 °	-121.533397 °
DWR ID	DWR_RD1001_01_s_2017_17				
Comment Code					
V1 : Control annual grass and weeds on the levee slopes and easements.					
Inspector Comment					
Maintain annual vegetation. Spring 2017.

View looking upstream of annual grasses, Spring 2017.

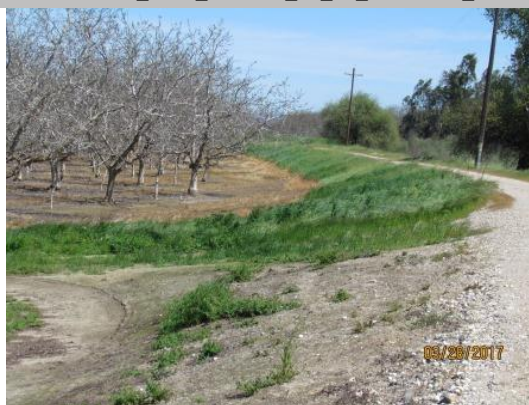
Photo 1 of 1 : SP_2017_RD1001_36_24_20170403_00027.jpg

LM Start	0.14	Rating **	M	Issue No.	24
LM End	1.52	Issue Type +	Ma	Location *	LS
Category	Earthen Levee			GPS Latitude/Longitude	
				Start	End
Item	Vegetation			38.978880 °	38.970688 °
				-121.471989 °	-121.494025 °
DWR ID	DWR_RD1001_01_s_2017_24				
Comment Code					
V1 : Control annual grass and weeds on the levee slopes and easements.					
Inspector Comment					
Maintain annual vegetation, Spring 2017,

View of annual vegetation looking upstream, landside. Spring 2017.

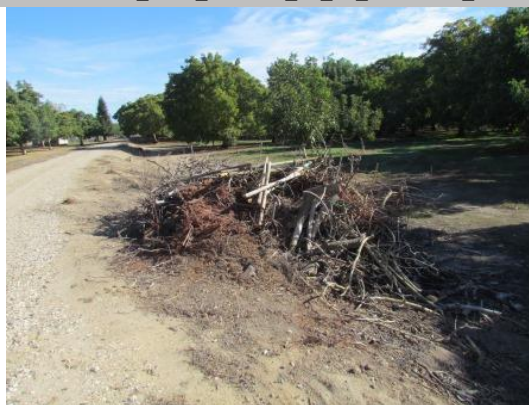
Photo 1 of 1 : SP_2017_RD1001_36_12_20170316_00009.jpg

LM Start	0.19	Rating **	M	Issue No.	12
LM End	0.19	Issue Type +	En	Location *	WS
Category	Earthen Levee			GPS Latitude/Longitude	
				Start	End
Item	Encroachments			38.978248 °	38.978248 °
				-121.472628 °	-121.472628 °
DWR ID	DWR_RD1001_01_f_2013_12				
Comment Code					
PR : Prunings					
Inspector Comment

This photo was taken from the levee crown facing east looking down the waterward slope at prunings stacked up at the toe. Fall 2014.

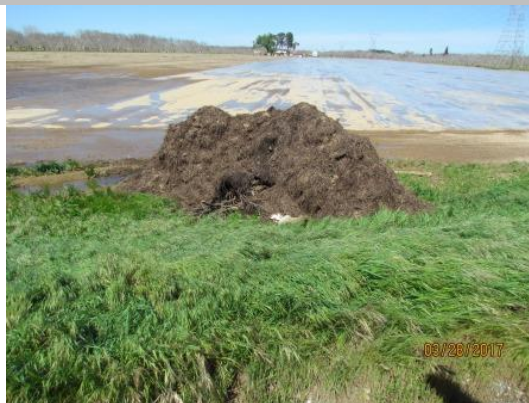
Photo 1 of 1 : SP_2017_RD1001_36_27_20170403_00028.jpg

LM Start	0.51	Rating **	M	Issue No.	27
LM End	0.51	Issue Type +	En	Location *	LS
Category	Earthen Levee			GPS Latitude/Longitude	
				Start	End
Item	Encroachments			38.975308 °	38.975308 °
				-121.476731 °	-121.476731 °
DWR ID	DWR_RD1001_01_s_2017_27				
Comment Code					
PR : Prunings					
Inspector Comment					
Debris/pruning's at landside levee toe, Spring 2017.

View of debris/pruning's at landside levee toe, Spring 2017.

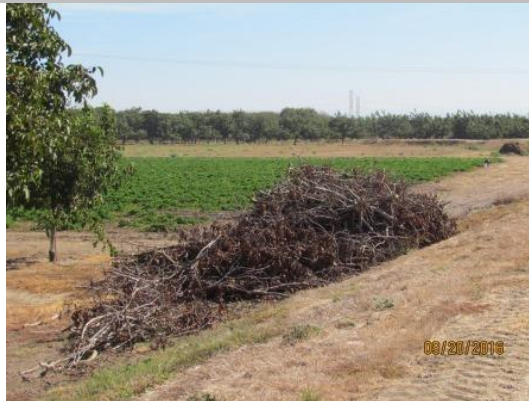
Photo 2 of 2 : SP_2017_RD1001_36_14_20170316_00011.jpg

LM Start	0.59	Rating **	M	Issue No.	14 (cont)
LM End	0.59	Issue Type +	En	Location *	LS

View of the prunings at the landside levee toe. Fall 2016.

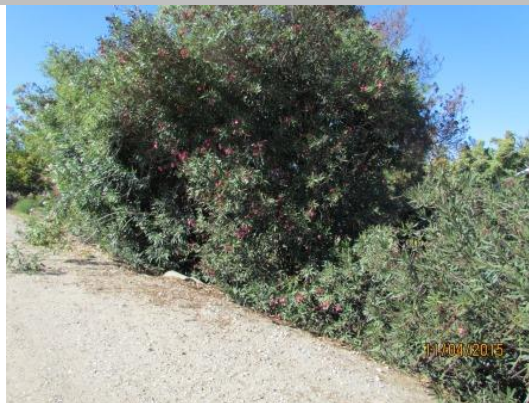
Photo 1 of 1 : SP_2017_RD1001_36_15_20170316_00012.jpg

LM Start	0.95	Rating **	U	Issue No.	15
LM End	0.95	Issue Type +	En	Location *	LS
Category	Earthen Levee			GPS Latitude/Longitude	
				Start	End
Item	Vegetation			38.974569 °	38.974569 °
				-121.484815 °	-121.484815 °
DWR ID	DWR_RD1001_01_s_2012_15				
Comment Code					
V6 : Landscaping					
Inspector Comment

View of the landscaping on the landside levee slope.

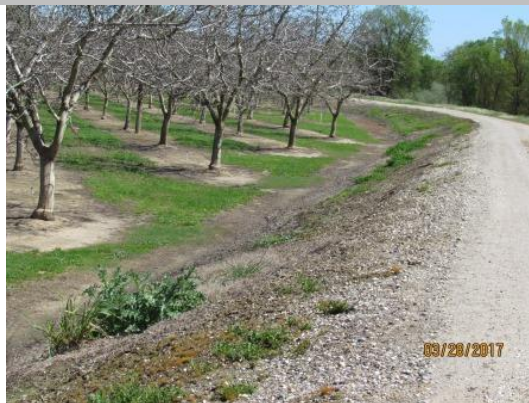
Photo 1 of 1 : SP_2017_RD1001_36_21_20170403_00026.jpg

LM Start	1.52	Rating **	A	Issue No.	21
LM End	1.86	Issue Type +	Ma	Location *	LS
Category	Earthen Levee			GPS Latitude/Longitude	
				Start	End
Item	Vegetation			38.970688 °	38.971170 °
				-121.494025 °	-121.500088 °
DWR ID	DWR_RD1001_01_s_2017_21				
Comment Code					
V1 : Control annual grass and weeds on the levee slopes and easements.					
Inspector Comment					
Well maintained annual vegetation. Spring 2017.

View of well maintained annual vegetation looking upstream, landside.
Spring 2017.

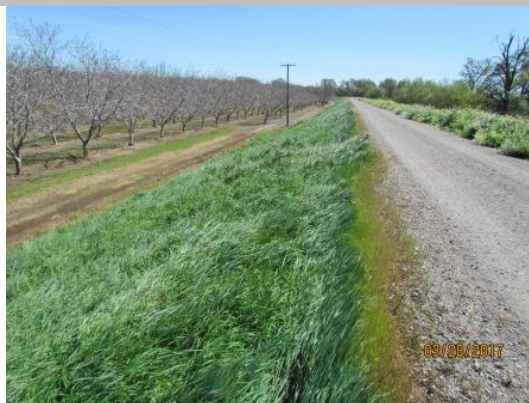
Photo 1 of 1 : SP_2017_RD1001_36_13_20170403_00021.jpg

LM Start	1.86	Rating **	U	Issue No.	13
LM End	3.83	Issue Type +	Ma	Location *	LS
Category	Earthen Levee			GPS Latitude/Longitude	
				Start	End
Item	Vegetation			38.971174 °	38.966768 °
				-121.500085 °	-121.533396 °
DWR ID	DWR_RD1001_01_s_2017_13				
Comment Code					
V1 : Control annual grass and weeds on the levee slopes and easements.					
Inspector Comment					
Maintain annual vegetation. Spring 2017.

View looking upstream of annual grasses, Spring 2017.

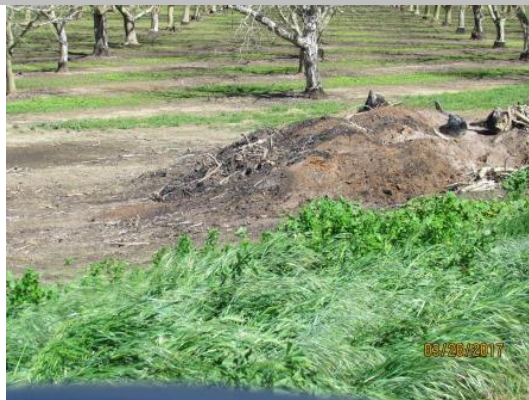
Photo 2 of 2 : SP_2017_RD1001_36_22_20170403_00024.jpg

LM Start	2.01	Rating **	A/W	Issue No.	22 (cont)	
LM End	2.01	Issue Type +	En	Location *	LS	
Category	Earthen Levee			GPS Latitude/Longitude		
				Start		End
Item	Encroachments			38.971093 °		38.971093 °
				-121.502895 °		-121.502895 °
DWR ID	DWR_RD1001_01_f_2016_22					
Comment Code						
PR : Prunings						
Inspector Comment						
Prunings have been burned, Spring 2017.

View of burned pruning's on the landside toe, Spring 2017.

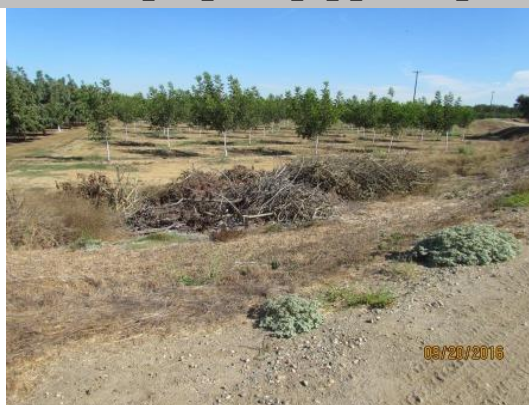
Photo 1 of 1 : SP_2017_RD1001_36_6_20170316_00004.jpg

LM Start	2.22	Rating **	M	Issue No.	6
LM End	2.22	Issue Type +	En	Location *	LS
Category	Earthen Levee			GPS Latitude/Longitude	
				Start	End
Item	Encroachments			38.969331 °	38.969331 °
				-121.505978 °	-121.505978 °
DWR ID	DWR_RD1001_01_f_2014_6				
Comment Code					
PR : Prunings					
Inspector Comment					
Prunings still at levee toe, Spring 2017.

This photo was taken of the landside looking upstream at prunings stacked up at the toe. Fall 2016.

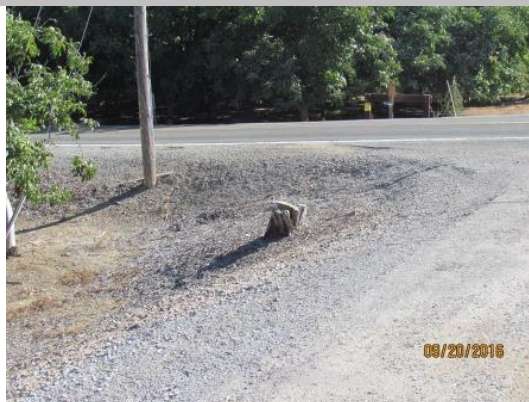
Photo 1 of 1 : SP_2017_RD1001_36_10_20170316_00008.jpg

LM Start	2.75	Rating **	N	Issue No.	10
LM End	2.75	Issue Type +	Ma	Location *	LS
Category	Earthen Levee			GPS Latitude/Longitude	
				Start	End
Item	Trim / Thin Trees			38.968376 °	38.968376 °
				-121.515626 °	-121.515626 °
DWR ID	DWR_RD1001_01_f_2015_10				
Comment Code					
T5 : Tree stumps.					
Inspector Comment					
Remove tree stump from lvee slope. Spring 2017.

View of stump on the landside slope looking upstream. Fall 2016.

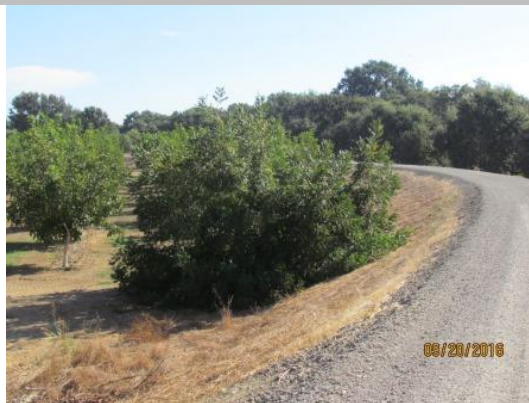
Photo 1 of 1 : SP_2017_RD1001_36_19_20170316_00015.jpg

LM Start	3.09	Rating **	M	Issue No.	19
LM End	3.09	Issue Type +	Ma	Location *	LS
Category	Earthen Levee			GPS Latitude/Longitude	
				Start	End
Item	Trim / Thin Trees			38.965660 °	38.965660 °
				-121.520548 °	-121.520548 °
DWR ID	DWR_RD1001_01_s_2016_19				
Comment Code					
T1 : Trim trees to at least five feet above ground level.					
Inspector Comment

View of a tree that need limbs trimmed. Fall 2016.

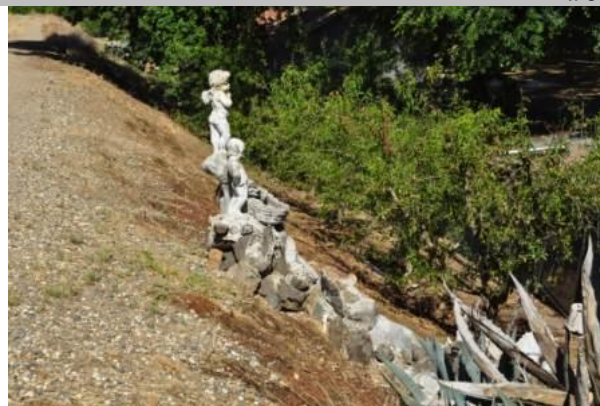
Photo 1 of 2 : SP_2017_RD1001_36_5_20170316_00002.jpg

LM Start	3.12	Rating **	M	Issue No.	5
LM End	3.17	Issue Type +	En	Location *	LS
Category	Earthen Levee			GPS Latitude/Longitude	
				Start	End
Item	Vegetation			38.965663 °	38.965705 °
				-121.521023 °	-121.522098 °
DWR ID	DWR_RD1001_01_s_2012_5				
Comment Code					
V6 : Landscaping					
Inspector Comment

Unit 1 Landscaping on levee slope. L/S

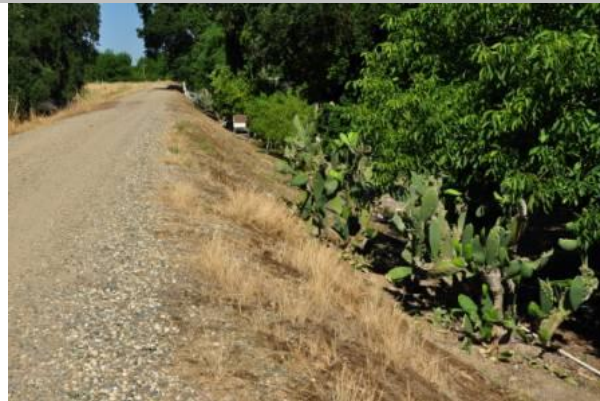
Photo 2 of 2 : SP_2017_RD1001_36_5_20170316_00003.jpg

LM Start	3.12	Rating **	M	Issue No.	5 (cont)
LM End	3.17	Issue Type +	En	Location *	LS

View of landscaping on landside slope.

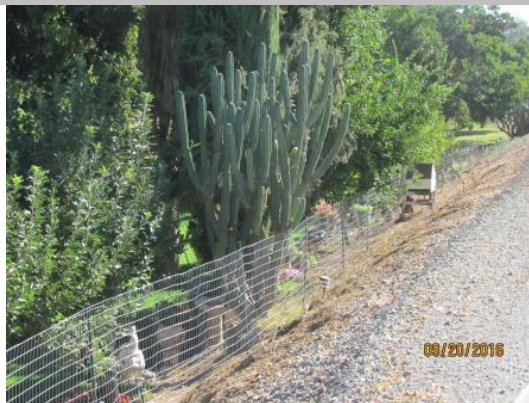
Photo 1 of 1 : SP_2017_RD1001_36_20_20170316_00016.jpg

LM Start	3.13	Rating **	M	Issue No.	20
LM End	3.17	Issue Type +	En	Location *	LS
Category	Earthen Levee			GPS Latitude/Longitude	
				Start	End
Item	Encroachments			38.965663 °	38.965672 °
				-121.521267 °	-121.521919 °
DWR ID	DWR_RD1001_01_f_2016_20				
Comment Code					
FE : Fence					
Inspector Comment					
Land owner has installed an unpermitted fence on the landside levee slope.

View of a fence on the landside levee slope looking upstream. Fall 2016.

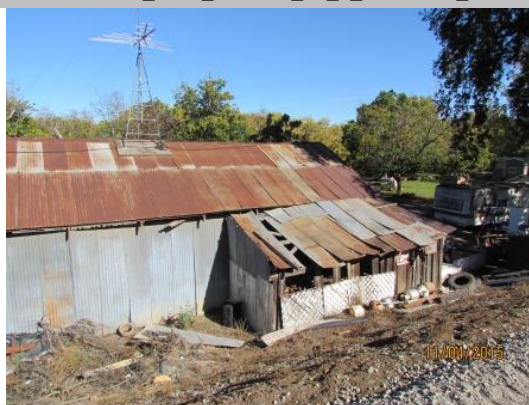
Photo 1 of 1 : SP_2017_RD1001_36_8_20170316_00006.jpg

LM Start	3.19	Rating **	U	Issue No.	8
LM End	3.19	Issue Type +	En	Location *	LS
Category	Earthen Levee			GPS Latitude/Longitude	
				Start	End
Item	Encroachments			38.965694 °	38.965694 °
				-121.522424 °	-121.522424 °
DWR ID	DWR_RD1001_01_f_2015_8				
Comment Code					
BU : Building					
Inspector Comment					
Remove debris and building to allow visibility and access to landside levee toe.

View of the shed at the landside levee toe.

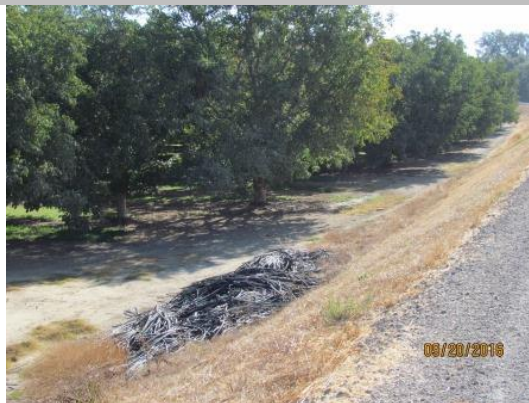
Photo 1 of 2 : SP_2017_RD1001_36_18_20170316_00014.jpg

LM Start	3.59	Rating **	M	Issue No.	18
LM End	3.59	Issue Type +	En	Location *	LS
Category	Earthen Levee			GPS Latitude/Longitude	
				Start	End
Item	Encroachments			38.965368 °	38.965368 °
				-121.529358 °	-121.529358 °
DWR ID	DWR_RD1001_01_f_2016_18				
Comment Code					
DE : Debris					
Inspector Comment					
Irrigation pipe still piled on landside toe. Spring 2017.

View of a pile of irrigation pipe on the landside levee toe looking upstream. Fall 2016.

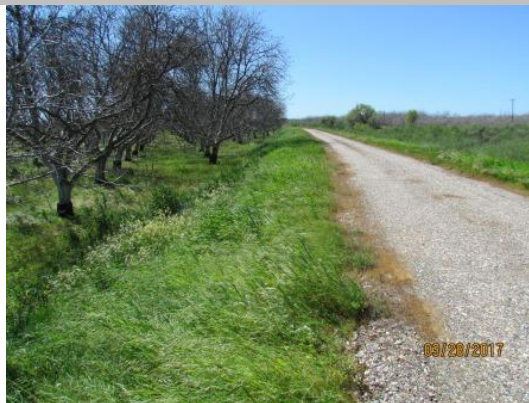
Photo 1 of 1 : SP_2017_RD1001_35_8_20170403_00027.jpg

LM Start	0.00	Rating **	U	Issue No.	8
LM End	3.64	Issue Type +	Ma	Location *	LS
Category	Earthen Levee			GPS Latitude/Longitude	
				Start	End
Item	Vegetation			38.971202 °	38.965845 °
				-121.473999 °	-121.533658 °
DWR ID	DWR_RD1001_02_s_2017_8				
Comment Code					
V1 : Control annual grass and weeds on the levee slopes and easements.					
Inspector Comment					
Maintain annual vegetation, Spring 2017.

View looking downstream of annual vegetation, Spring 2017.

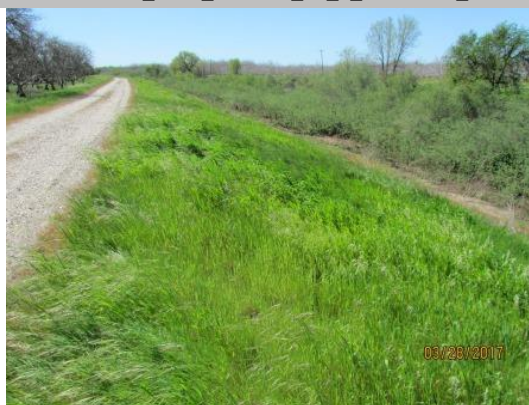
Photo 1 of 1 : SP_2017_RD1001_35_9_20170403_00028.jpg

LM Start	0.00	Rating **	U	Issue No.	9
LM End	3.64	Issue Type +	Ma	Location *	WS
Category	Earthen Levee			GPS Latitude/Longitude	
				Start	End
Item	Vegetation			38.971219 °	38.965845 °
				-121.474038 °	-121.533658 °
DWR ID	DWR_RD1001_02_s_2017_9				
Comment Code					
V1 : Control annual grass and weeds on the levee slopes and easements.					
Inspector Comment					
Maintain annual vegetation, Spring 2017.

View looking downstream of annual vegetation, Spring 2017.

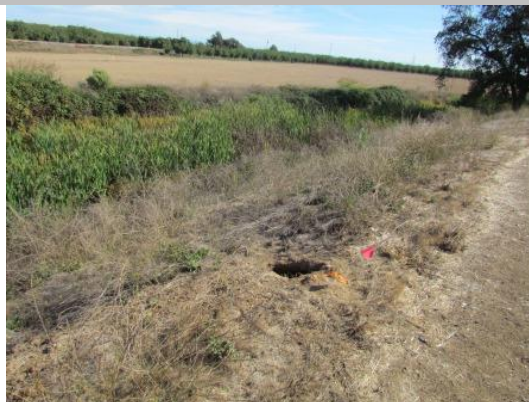
Photo 1 of 3 : SP_2017_RD1001_35_4_20170316_00001.jpg

LM Start	0.27	Rating **	A/W	Issue No.	4
LM End	0.27	Issue Type +	Ma	Location *	WS
Category	Earthen Levee			GPS Latitude/Longitude	
				Start	End
Item	Animal Control			38.974323 °	38.974323 °
				-121.476442 °	-121.476442 °
DWR ID	DWR_RD1001_02_f_2014_4				
Comment Code					
A3 : No rodents visible, but rodent burrows visible; need to backfill and compact or grout burrows.					
Inspector Comment					
There is no animal activity at this location, the existing hole near the crown has been backfill & repaired by the District, Spring 2017.

This photo was taken from the levee crown facing east looking down the waterward slope at an animal burrow. Fall 2014.

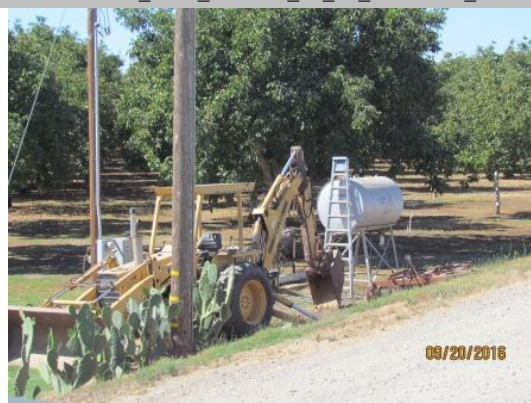
Photo 1 of 1 : SP_2017_RD1001_35_21_20170316_00012.jpg

LM Start	0.54	Rating **	M	Issue No.	21
LM End	0.54	Issue Type +	En	Location *	LS
Category	Earthen Levee			GPS Latitude/Longitude	
				Start	End
Item	Encroachments			38.974348 °	38.974348 °
				-121.481498 °	-121.481498 °
DWR ID	DWR_RD1001_02_f_2016_21				
Comment Code					
EQ : Equipment					
Inspector Comment					
Backhoe and tank at landside levee toe need to be removed from easement.

View of an backhoe and tank at landside levee toe looking downstream. Fall 2016.

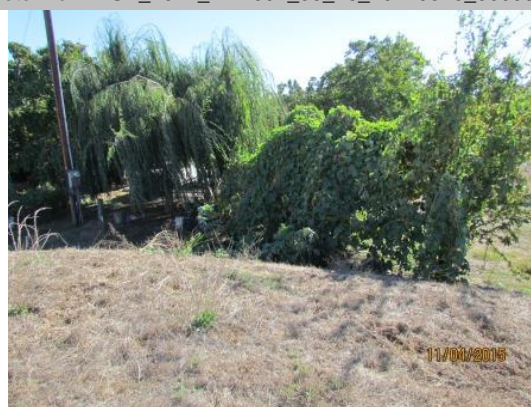
Photo 1 of 1 : SP_2017_RD1001_35_16_20170316_00009.jpg

LM Start	0.63	Rating **	M	Issue No.	16
LM End	0.63	Issue Type +	En	Location *	LS
Category	Earthen Levee			GPS Latitude/Longitude	
				Start	End
Item	Vegetation			38.974198 °	38.974198 °
				-121.483150 °	-121.483150 °
DWR ID	DWR_RD1001_02_s_2012_16				
Comment Code					
V6 : Landscaping					
Inspector Comment

View of the landscaping at the landside levee toe.

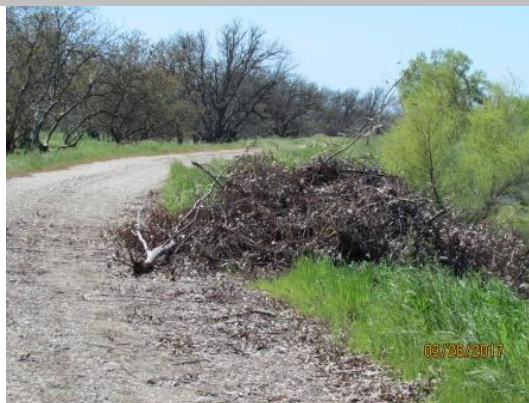
Photo 1 of 1 : SP_2017_RD1001_35_14_20170403_00029.jpg

LM Start	1.11	Rating **	M	Issue No.	14
LM End	1.11	Issue Type +	Ma	Location *	WS
Category	Earthen Levee			GPS Latitude/Longitude	
				Start	End
Item	Encroachments			38.971521 °	38.971521 °
				-121.490987 °	-121.490987 °
DWR ID	DWR_RD1001_02_s_2017_14				
Comment Code					
PR : Prunings					
Inspector Comment					
Remove prunings from levees hinge point, Spring 2017.

View looking downstream of pruning's on levee hinge point, Spring 2017.

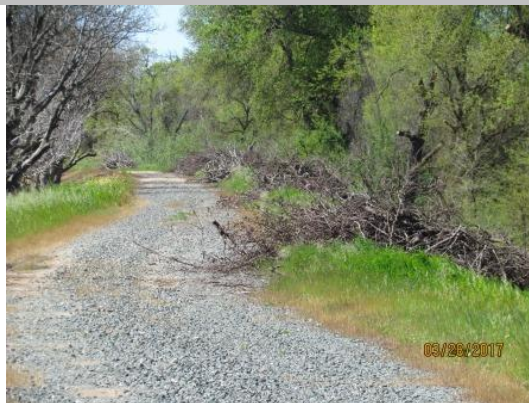
Photo 1 of 1 : SP_2017_RD1001_35_20_20170403_00032.jpg

LM Start	1.38	Rating **	M	Issue No.	20
LM End	1.69	Issue Type +	Ma	Location *	WS
Category	Earthen Levee			GPS Latitude/Longitude	
				Start	End
Item	Encroachments			38.969622 °	38.970249 °
				-121.495304 °	-121.501040 °
DWR ID	DWR_RD1001_02_s_2017_20				
Comment Code					
PR : Prunings					
Inspector Comment					
Remove prunings from levees hinge point, Spring 2017.

View looking downstream of pruning's on length of levee hinge point, Spring 2017.

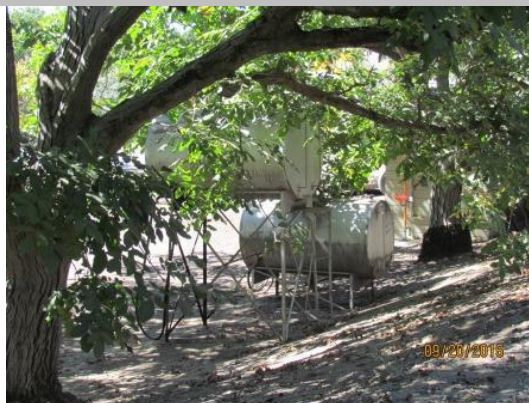
Photo 1 of 1 : SP_2017_RD1001_35_23_20170316_00014.jpg

LM Start	1.70	Rating **	M	Issue No.	23
LM End	1.70	Issue Type +	En	Location *	LS
Category	Earthen Levee			GPS Latitude/Longitude	
				Start	End
Item	Encroachments			38.970260 °	38.970260 °
				-121.501246 °	-121.501246 °
DWR ID	DWR_RD1001_02_f_2016_23				
Comment Code					
TA : Tank					
Inspector Comment					
Two tanks that are at the landside levee toe and should be moved from the easement.

View of two tanks that are at the landside levee toe. Fall 2016.

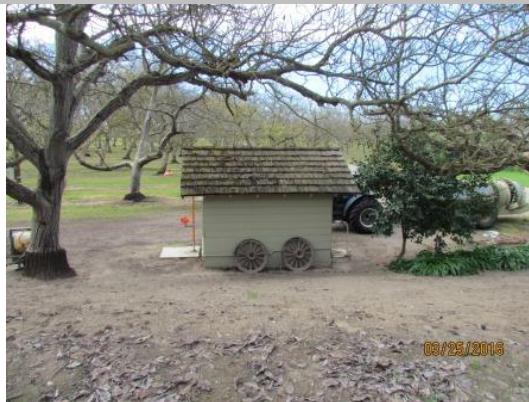
Photo 1 of 1 : SP_2017_RD1001_35_18_20170316_00010.jpg

LM Start	1.71	Rating **	M	Issue No.	18
LM End	1.71	Issue Type +	En	Location *	LS
Category	Earthen Levee			GPS Latitude/Longitude	
				Start	End
Item	Encroachments			38.970264 °	38.970264 °
				-121.501343 °	-121.501343 °
DWR ID	DWR_RD1001_02_s_2016_18				
Comment Code					
BU : Building					
Inspector Comment

Shed at landside toe.

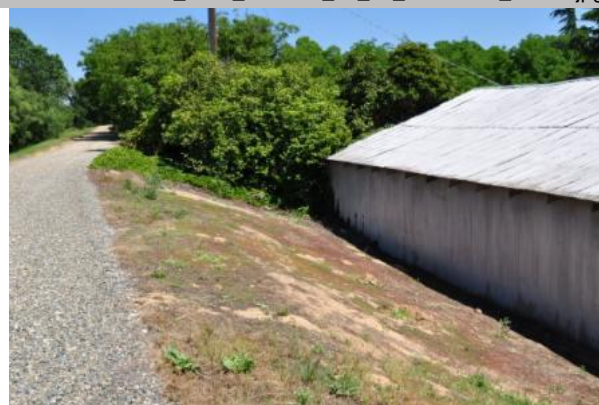
Photo 1 of 1 : SP_2017_RD1001_35_11_20170316_00006.jpg

LM Start	1.75	Rating **	U	Issue No.	11
LM End	1.75	Issue Type +	En	Location *	LS
Category	Earthen Levee			GPS Latitude/Longitude	
				Start	End
Item	Encroachments			38.970347 °	38.970347 °
				-121.502027 °	-121.502027 °
DWR ID	DWR_RD1001_02_s_2012_11				
Comment Code					
BU : Building					
Inspector Comment

RD 1001 Unit 2 - L/S -Building @ toe.

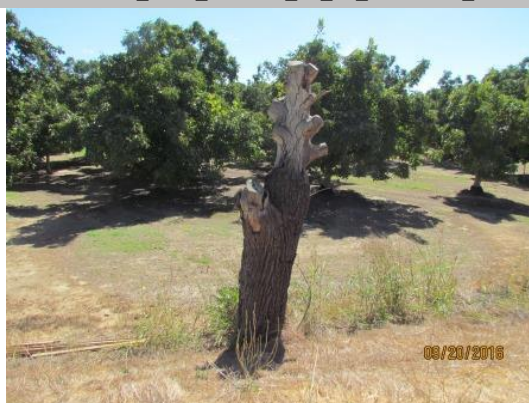
Photo 1 of 1 : SP_2017_RD1001_35_13_20170316_00008.jpg

LM Start	1.89	Rating **	N	Issue No.	13
LM End	1.89	Issue Type +	Ma	Location *	LS
Category	Earthen Levee			GPS Latitude/Longitude	
				Start	End
Item	Trim / Thin Trees			38.969423 °	38.969423 °
				-121.504225 °	-121.504225 °
DWR ID	DWR_RD1001_02_f_2015_13				
Comment Code					
T5 : Tree stumps.					
Inspector Comment					
Large stump at the landside levee toe should be removed.

View of large stump at the landside levee toe. Fall 2016.

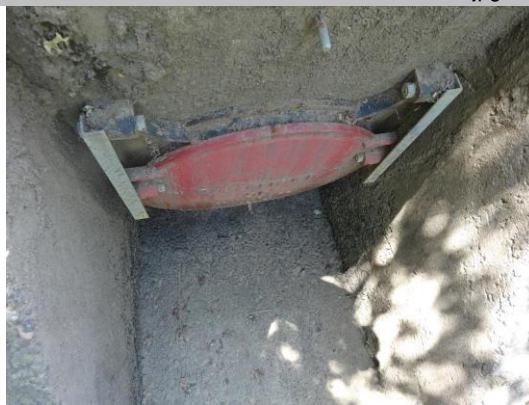
Photo 2 of 3 : UCIP_SP_2017_14008_23107.jpg

LM Start	2.28	Rating **	M	Issue No.	55 (cont)
LM End	2.28	Issue Type +	Ma	Location *	LS

WS- outfall pipe with flap gate in concrete wing wall.

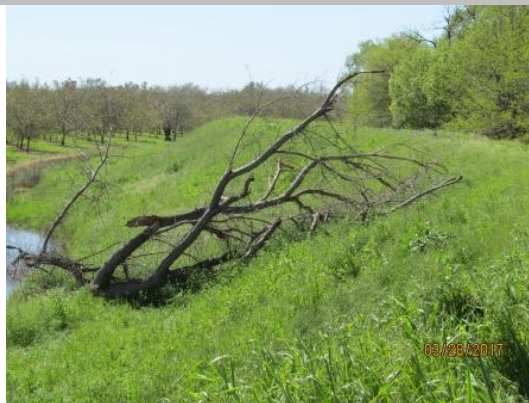
Photo 1 of 1 : SP_2017_RD1001_35_26_20170403_00034.jpg

LM Start	3.10	Rating **	M	Issue No.	26
LM End	3.10	Issue Type +	Ma	Location *	LS
Category	Earthen Levee			GPS Latitude/Longitude	
				Start	End
Item	Trim / Thin Trees			38.964742 °	38.964742 °
				-121.524459 °	-121.524459 °
DWR ID	DWR_RD1001_02_s_2017_26				
Comment Code					
T1 : Trim trees to at least five feet above ground level.					
Inspector Comment					
Tree that has fallen last rainy season needs to be removed from slope, Spring 2017.

View looking downstream of a tree that has fallen last rainy season and needs to be removed from slope, Spring 2017.

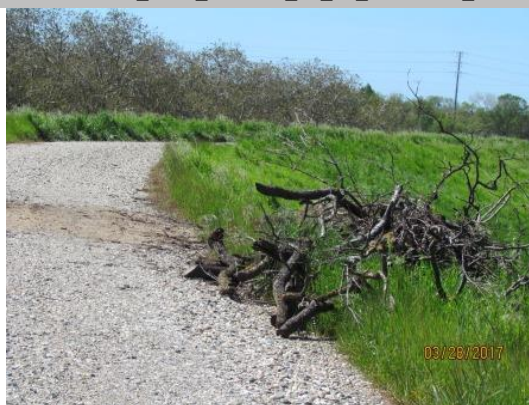
Photo 1 of 1 : SP_2017_RD1001_35_27_20170403_00035.jpg

LM Start	3.25	Rating **	M	Issue No.	27
LM End	3.25	Issue Type +	Ma	Location *	WS
Category	Earthen Levee			GPS Latitude/Longitude	
				Start	End
Item	Encroachments			38.963728 °	38.963728 °
				-121.526859 °	-121.526859 °
DWR ID	DWR_RD1001_02_s_2017_27				
Comment Code					
PR : Prunings					
Inspector Comment					
Remove prunings from levees hinge point, Spring 2017.

View looking downstream of pruning's on levee hinge point, Spring 2017.

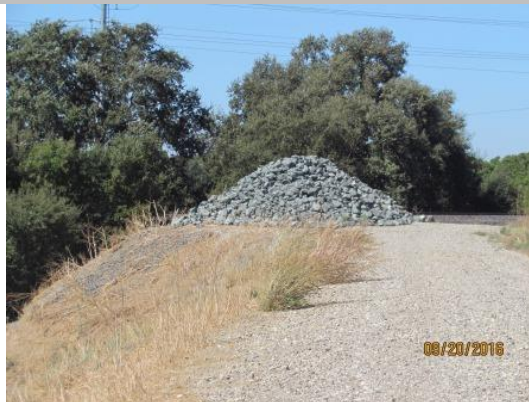
Photo 1 of 1 : SP_2017_RD1001_35_24_20170316_00015.jpg

LM Start	3.58	Rating **	A	Issue No.	24
LM End	3.58	Issue Type +	Ma	Location *	LS
Category	Earthen Levee			GPS Latitude/Longitude	
				Start	End
Item	Emergency Supplies & Equipment			38.965345 °	38.965345 °
				-121.532615 °	-121.532615 °
DWR ID	DWR_RD1001_02_f_2016_24				
Comment Code					
Inspector Comment					
Stockpiled flood fight material. Fall 2016.

View of stockpiled flood fight material. Fall 2016.

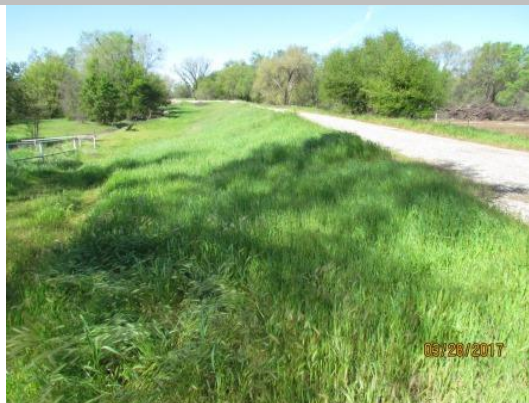
Photo 1 of 1 : SP_2017_RD1001_37_14_20170403_00043.jpg

LM Start	0.01	Rating **	M	Issue No.	14
LM End	12.56	Issue Type +	Ma	Location *	LS
Category	Earthen Levee			GPS Latitude/Longitude	
				Start	End
Item	Vegetation			39.006585 °	38.941262 °
				-121.375117 °	-121.567534 °
DWR ID	DWR_RD1001_03_s_2017_14				
Comment Code					
V1 : Control annual grass and weeds on the levee slopes and easements.					
Inspector Comment					
Maintain annual vegetation. Spring 2017.

View looking downstream of annual vegetation. Spring 2017.

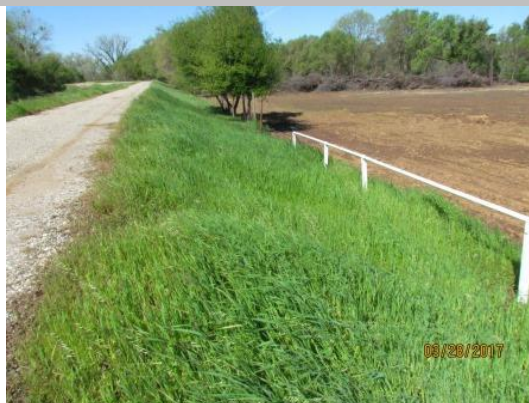
Photo 1 of 1 : SP_2017_RD1001_37_15_20170403_00044.jpg

LM Start	0.01	Rating **	M	Issue No.	15
LM End	12.56	Issue Type +	Ma	Location *	WS
Category	Earthen Levee			GPS Latitude/Longitude	
				Start	End
Item	Vegetation			39.006586 °	38.941259 °
				-121.375118 °	-121.567535 °
DWR ID	DWR_RD1001_03_s_2017_15				
Comment Code					
V1 : Control annual grass and weeds on the levee slopes and easements.					
Inspector Comment					
Maintain annual vegetation. Spring 2017.

View looking downstream of annual vegetation. Spring 2017.

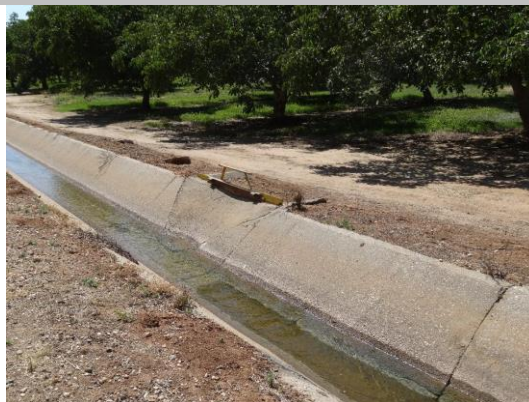
Photo 3 of 3 : UCIP_SP_2017_14128_23309.jpg

LM Start	0.88	Rating **	M	Issue No.	911 (cont)
LM End	0.88	Issue Type +	En	Location *	LS

LS- no pipe or structure found on landside.

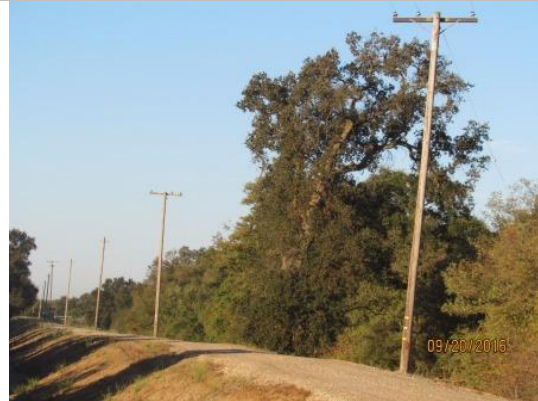
Photo 1 of 1 : SP_2017_RD1001_37_3_20170316_00004.jpg

LM Start	1.16	Rating **	M	Issue No.	3
LM End	1.78	Issue Type +	En	Location *	WS
Category	Earthen Levee			GPS Latitude/Longitude	
				Start	End
Item	Encroachments			39.005730 °	38.999534 °
				-121.396111 °	-121.404395 °
DWR ID	DWR_RD1001_03_s_2012_3				
Comment Code					
PO : Pole					
Inspector Comment					
Unpermitted Power Poles on the crown along waterside shoulder.

View of Power Poles along waterside shoulder. Fall 2016.

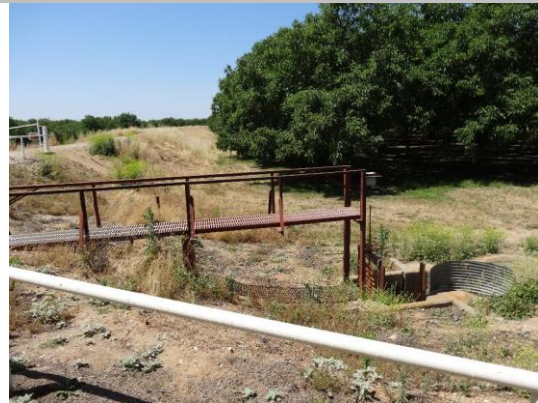
Photo 1 of 3 : UCIP_SP_2017_41727_23325.jpg

LM Start	1.85	Rating **	M	Issue No.	912
LM End	1.85	Issue Type +	En	Location *	WS
Category	Supplemental			GPS Latitude/Longitude	
				Start	End
Item	DWR UCIP Field Study			38.998780 °	38.998780 °
				-121.405322 °	-121.405322 °
DWR ID

Comment Code					
Inspector Comment					
FS_ID:41727					
DS_ID:22561					
EP_NO: 4505					
Repair Type: Non-Urgent					
Crossing Status: Found					
UCIP Comments: Two small steel pipes sleeved through 30-inch CMP may be a compliance issue as slidegate cannot close.- this may have been converted into drainage pipe (?) - big CMP standpipe on WS.					
FIELD_STRUCT_DESC: 30-inch concrete-encased corrugated-metal irrigation pipe through the levee, 11.0 feet below the crown, concrete headwall at the waterward toe, metal walkway on the waterward side to the slide gate, pipe discharges into a 48-inch concrete standpipe at the landward toe, two vertical pumps (Permit No. 4505, 1964). O&M Manual Sac 141.1, August 1955.					
FS Date: 5/21/2013

WS- steel walkway, CMP and concrete headwall

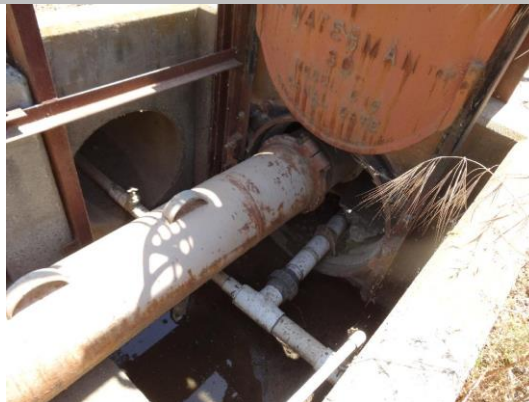
Photo 3 of 3 : UCIP_SP_2017_41727_23323.jpg

FS_ID:41727
DS_ID:22561
EP_NO: 4505
Repair Type: Non-Urgent
Crossing Status: Found
UCIP Comments: Two small steel pipes sleeved through 30-inch CMP may be a compliance issue as slidegate cannot close.- this may have been converted into drainage pipe (?) - big CMP standpipe on WS.
FIELD_STRUCT_DESC: 30-inch concrete-encased corrugated-metal irrigation pipe through the levee, 11.0 feet below the crown, concrete headwall at the waterward toe, metal walkway on the waterward side to the slide gate, pipe discharges into a 48-inch concrete standpipe at the landward toe, two vertical pumps (Permit No. 4505, 1964). O&M Manual Sac 141.1, August 1955.
FS Date: 5/21/2013

WS- two steel pipes are sleeved through 30-inch CMP.

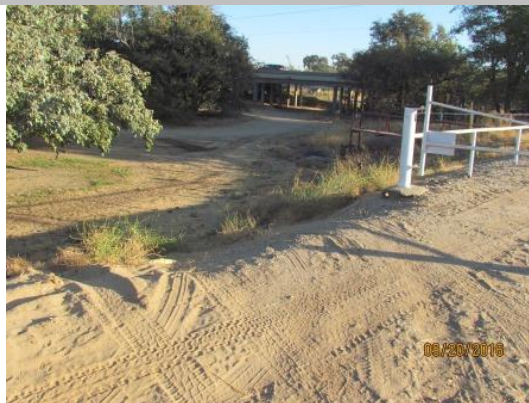
Photo 1 of 1 : SP_2017_RD1001_37_28_20170316_00018.jpg

LM Start	1.87	Rating **	M	Issue No.	28
LM End	1.87	Issue Type +	Ma	Location *	WS
Category	Earthen Levee			GPS Latitude/Longitude	
				Start	End
Item	Slope Stability			38.998608 °	38.998608 °
				-121.405570 °	-121.405570 °
DWR ID	DWR_RD1001_03_s_2013_28				
Comment Code					
S3 : Repair the levee slope damaged by vehicle traffic and prevent access where possible.					
Inspector Comment					
Continual damage to waterside slope caused by vehicles, suggest blocking access.

Continual damage to waterside slope caused by vehicles. Fall 2016.

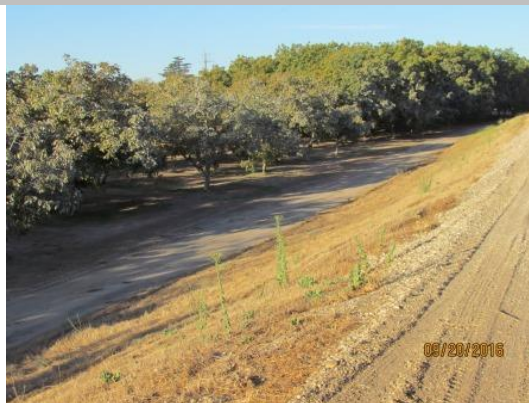
Photo 2 of 2 : SP_2017_RD1001_37_30_20170316_00021.jpg

LM Start	2.28	Rating **	M	Issue No.	30 (cont)	
LM End	2.28	Issue Type +	Ma	Location *	LS	
Category	Earthen Levee			GPS Latitude/Longitude		
				Start		End
Item	Slope Stability			38.996302 °		38.996302 °
				-121.412285 °		-121.412285 °
DWR ID	DWR_RD1001_03_s_2013_30					
Comment Code						
S3 : Repair the levee slope damaged by vehicle traffic and prevent access where possible.						
Inspector Comment						
Damage to landside slope has been repaired. Continue to monitor area.

Damage to landside slope has been repaired. Fall 2016.

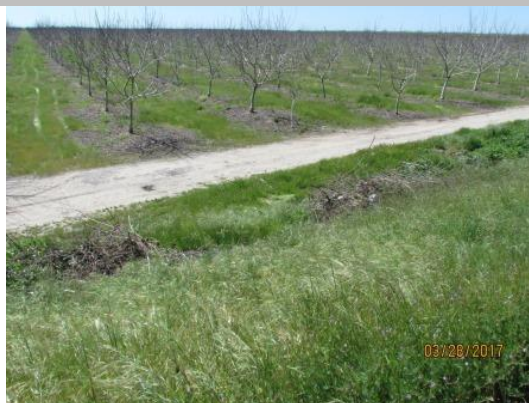
Photo 1 of 1 : SP_2017_RD1001_37_16_20170403_00045.jpg

LM Start	2.56	Rating **	M	Issue No.	16
LM End	2.56	Issue Type +	En	Location *	LS
Category	Earthen Levee			GPS Latitude/Longitude	
				Start	End
Item	Encroachments			38.995681 °	38.995681 °
				-121.417341 °	-121.417341 °
DWR ID	DWR_RD1001_03_s_2017_16				
Comment Code					
PR : Prunings					
Inspector Comment					
Pruning's at levee toe need to be removed. Spring 2017.

View of pruning's at levee toe that need to be removed. Spring 2017.

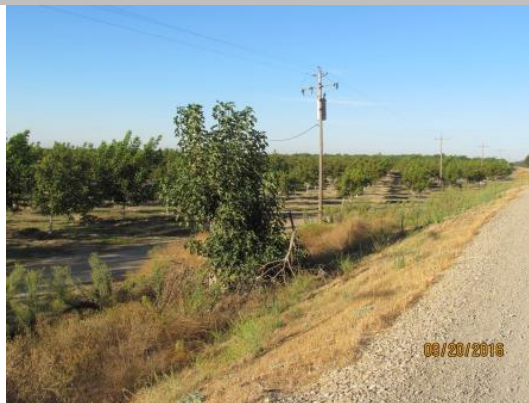
Photo 1 of 1 : SP_2017_RD1001_37_36_20170316_00024.jpg

LM Start	2.59	Rating **	M	Issue No.	36
LM End	2.59	Issue Type +	Ma	Location *	LS
Category	Earthen Levee			GPS Latitude/Longitude	
				Start	End
Item	Trim / Thin Trees			38.995583 °	38.995583 °
				-121.417995 °	-121.417995 °
DWR ID	DWR_RD1001_03_s_2015_36				
Comment Code					
T3 : Trim and thin trees to allow visibility of the ground and room to flood fight.					
Inspector Comment					
Tree less than 4" in diameter should be removed

View of a small starter tree on landside slope looking downstream that is less than 4" in diameter.

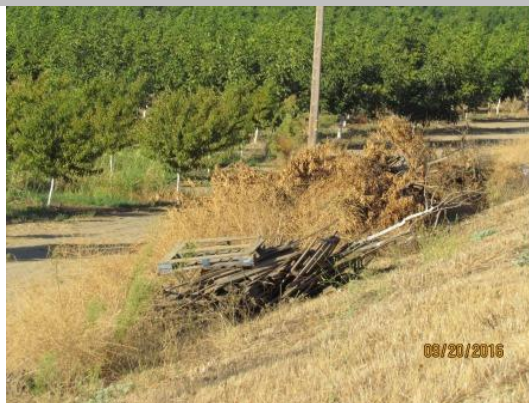
Photo 1 of 1 : SP_2017_RD1001_37_5_20170316_00006.jpg

LM Start	2.76	Rating **	M	Issue No.	5
LM End	2.76	Issue Type +	En	Location *	LS
Category	Earthen Levee			GPS Latitude/Longitude	
				Start	End
Item	Encroachments			38.994999 °	38.994999 °
				-121.421047 °	-121.421047 °
DWR ID	DWR_RD1001_03_f_2015_5				
Comment Code					
PR : Prunings					
Inspector Comment

View of the prunings at the landside levee toe. Fall 2016.

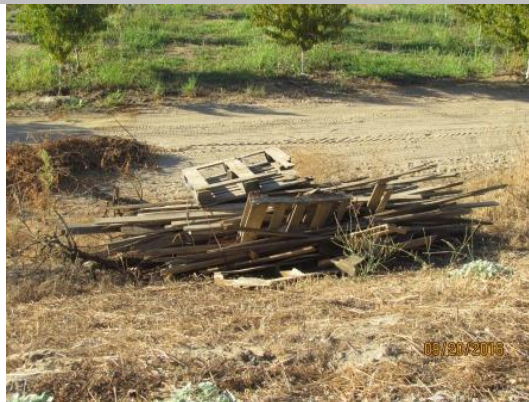
Photo 1 of 1 : SP_2017_RD1001_37_37_20170316_00025.jpg

LM Start	2.76	Rating **	M	Issue No.	37
LM End	2.76	Issue Type +	En	Location *	LS
Category	Earthen Levee			GPS Latitude/Longitude	
				Start	End
Item	Encroachments			38.994983 °	38.994983 °
				-121.421069 °	-121.421069 °
DWR ID	DWR_RD1001_03_s_2015_37				
Comment Code					
DE : Debris					
Inspector Comment					
Wood debris piled up at levee toe.

View of debris pile at landside levee toe. Fall 2016.

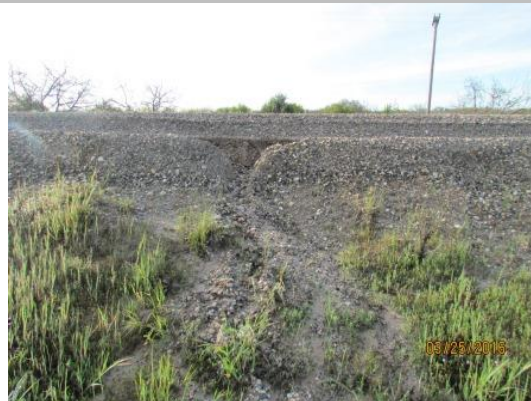
Photo 1 of 1 : SP_2017_RD1001_37_21_20170316_00015.jpg

LM Start	3.57	Rating **	M	Issue No.	21	
LM End	3.57	Issue Type +	Ma	Location *	WS	
Category	Earthen Levee			GPS Latitude/Longitude		
				Start		End
Item	Erosion / Bank Caving			38.991390 °		38.991390 °
				-121.435268 °		-121.435268 °
DWR ID	DWR_RD1001_03_s_2016_21					
Comment Code						
E2 : Schedule repair of erosion site prior to the next inspection.						
Inspector Comment

Erosion on waterside slope. Remains as of Fall 2016.

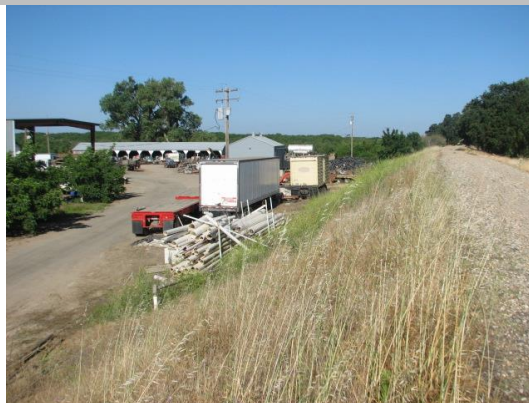
Photo 1 of 1 : SP_2017_RD1001_37_7_20170316_00007.jpg

LM Start	4.03	Rating **	M	Issue No.	7
LM End	4.09	Issue Type +	En	Location *	LS
Category	Earthen Levee			GPS Latitude/Longitude	
				Start	End
Item	Encroachments			38.991299 °	38.991413 °
				-121.443830 °	-121.444865 °
DWR ID	DWR_RD1001_03_s_2012_7				
Comment Code					
MA : Material					
Inspector Comment

Irrigation pipe equipment and plastic cans within the easement of the levee. Spring 2013

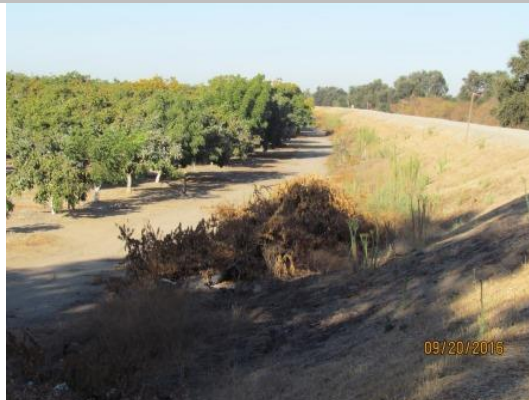
Photo 1 of 2 : SP_2017_RD1001_37_9_20170316_00009.jpg

LM Start	4.46	Rating **	M	Issue No.	9
LM End	4.46	Issue Type +	En	Location *	LS
Category	Earthen Levee			GPS Latitude/Longitude	
				Start	End
Item	Encroachments			38.991867 °	38.991867 °
				-121.451743 °	-121.451743 °
DWR ID	DWR_RD1001_03_s_2013_9				
Comment Code					
PR : Prunings					
Inspector Comment					
Pruning's still on levee toe, Spring 2017.

Drip irrigation tubing has been removed that was within the easement of the landside levee. There is a new pile of pruning's at the toe. Fall 2016

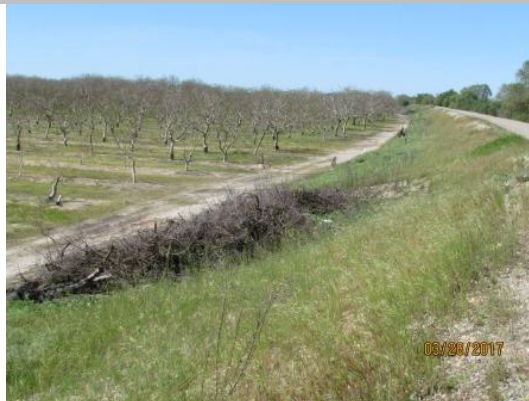
Photo 2 of 2 : SP_2017_RD1001_37_9_20170403_00049.jpg

There is a still a pile of pruning's at the toe. Spring 2017.

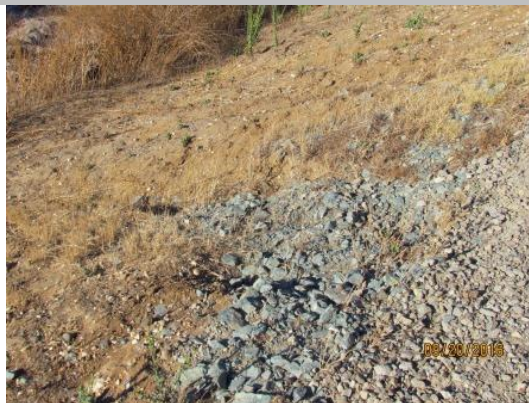
Photo 1 of 1 : SP_2017_RD1001_37_31_20170316_00022.jpg

LM Start	4.48	Rating **	M	Issue No.	31
LM End	4.48	Issue Type +	Ma	Location *	LS
Category	Earthen Levee			GPS Latitude/Longitude	
				Start	End
Item	Erosion / Bank Caving			38.991851 °	38.991851 °
				-121.452116 °	-121.452116 °
DWR ID	DWR_RD1001_03_f_2016_31				
Comment Code					
E2 : Schedule repair of erosion site prior to the next inspection.					
Inspector Comment

View of erosion in the landside levee slope looking downstream. Fall 2016.

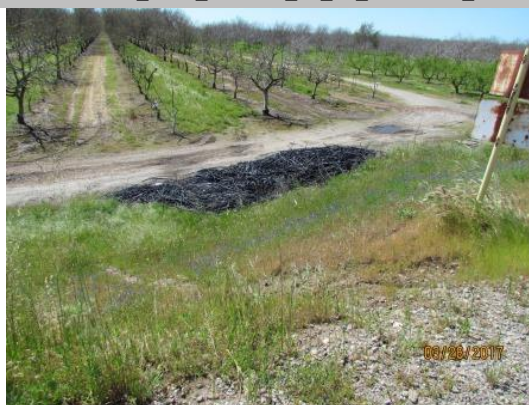
Photo 1 of 1 : SP_2017_RD1001_37_35_20170403_00050.jpg

LM Start	4.49	Rating **	M	Issue No.	35
LM End	4.69	Issue Type +	En	Location *	LS
Category	Earthen Levee			GPS Latitude/Longitude	
				Start	End
Item	Encroachments			38.991859 °	38.991425 °
				-121.452178 °	-121.455883 °
DWR ID	DWR_RD1001_03_s_2017_35				
Comment Code					
PR : Prunings					
Inspector Comment					
Remove drip irrigation along levee toe. Spring 2017.

View looking downstream of drip irrigation debris at levee toe, Spring 2017.

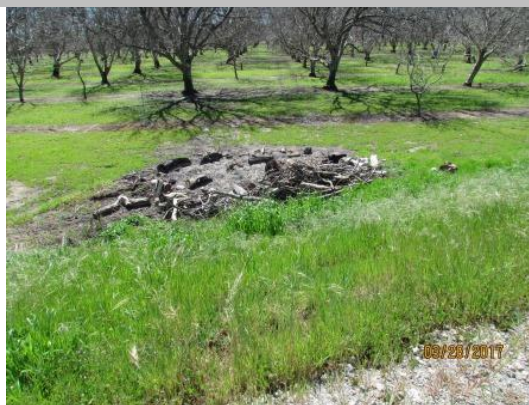
Photo 1 of 1 : SP_2017_RD1001_37_12_20170403_00051.jpg

LM Start	5.64	Rating **	A/W	Issue No.	12
LM End	5.64	Issue Type +	En	Location *	LS
Category	Earthen Levee			GPS Latitude/Longitude	
				Start	End
Item	Encroachments			38.986659 °	38.986659 °
				-121.472444 °	-121.472444 °
DWR ID	DWR_RD1001_03_s_2017_12				
Comment Code					
PR : Prunings					
Inspector Comment					
Pruning's have been burned from levee toe. Spring 2017.

View of pruning's that have been burned, Spring 2017.

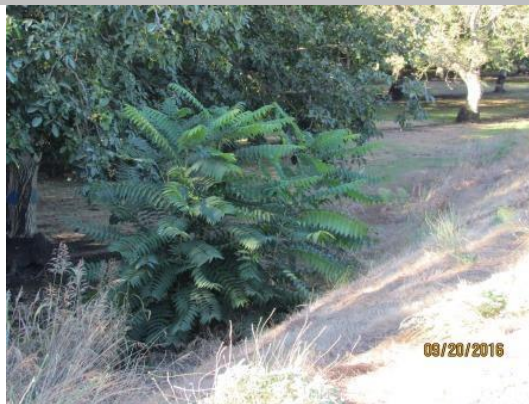
Photo 1 of 2 : SP_2017_RD1001_37_32_20170316_00023.jpg

LM Start	5.81	Rating **	A/W	Issue No.	32
LM End	5.81	Issue Type +	Ma	Location *	LS
Category	Earthen Levee			GPS Latitude/Longitude	
				Start	End
Item	Trim / Thin Trees			38.985882 °	38.985882 °
				-121.475394 °	-121.475394 °
DWR ID	DWR_RD1001_03_f_2016_32				
Comment Code					
T2 : Thin trees to allow visibility of the ground and room to flood fight.					
Inspector Comment					
Trees less than 4" in diameter should be removed.

View of starter tree with diameter less than 4". Fall 2016.

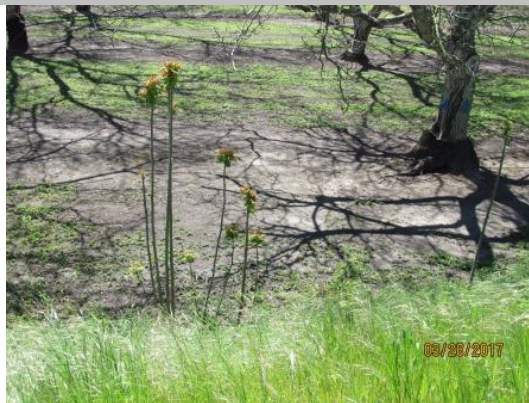
Photo 2 of 2 : SP_2017_RD1001_37_32_20170403_00052.jpg

LM Start	5.81	Rating **	A/W	Issue No.	32 (cont)	
LM End	5.81	Issue Type +	Ma	Location *	LS	
Category	Earthen Levee			GPS Latitude/Longitude		
				Start		End
Item	Trim / Thin Trees			38.985882 °		38.985882 °
				-121.475394 °		-121.475394 °
DWR ID	DWR_RD1001_03_f_2016_32					
Comment Code						
T2 : Thin trees to allow visibility of the ground and room to flood fight.						
Inspector Comment						
Trees less than 4" in diameter should be removed.

View of where starter tree was removed but new starters have sprouted up, Spring 2017.

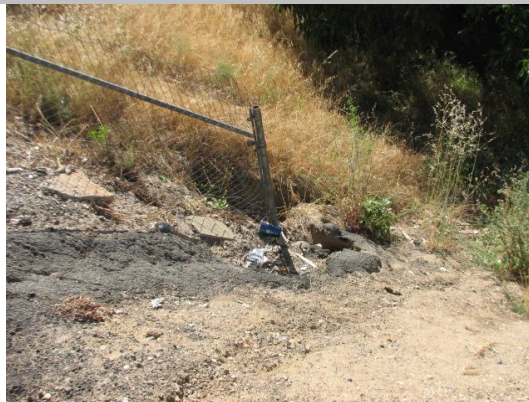
Photo 1 of 2 : SP_2017_RD1001_37_38_20170316_00026.jpg

LM Start	6.47	Rating **	M	Issue No.	38
LM End	6.47	Issue Type +	Ma	Location *	LS
Category	Earthen Levee			GPS Latitude/Longitude	
				Start	End
Item	Erosion / Bank Caving			38.984019 °	38.984019 °
				-121.487404 °	-121.487404 °
DWR ID	DWR_RD1001_03_s_2013_38				
Comment Code					
E2 : Schedule repair of erosion site prior to the next inspection.					
Inspector Comment

Erosion caused by run off from the roadway. Spring 2013

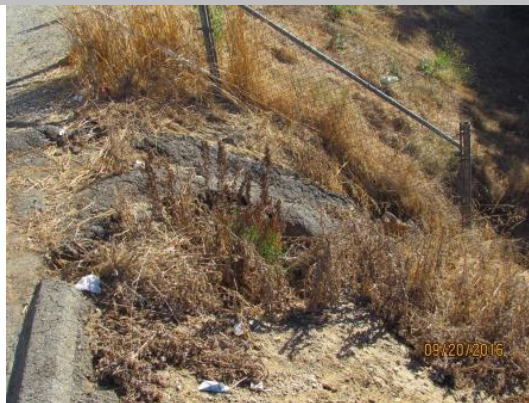
Photo 2 of 2 : SP_2017_RD1001_37_38_20170316_00027.jpg

LM Start	6.47	Rating **	M	Issue No.	38 (cont)	
LM End	6.47	Issue Type +	Ma	Location *	LS	
Category	Earthen Levee			GPS Latitude/Longitude		
				Start		End
Item	Erosion / Bank Caving			38.984019 °		38.984019 °
				-121.487404 °		-121.487404 °
DWR ID	DWR_RD1001_03_s_2013_38					
Comment Code						
E2 : Schedule repair of erosion site prior to the next inspection.						
Inspector Comment

Erosion caused by run off from the roadway still exist. Fall 2016.

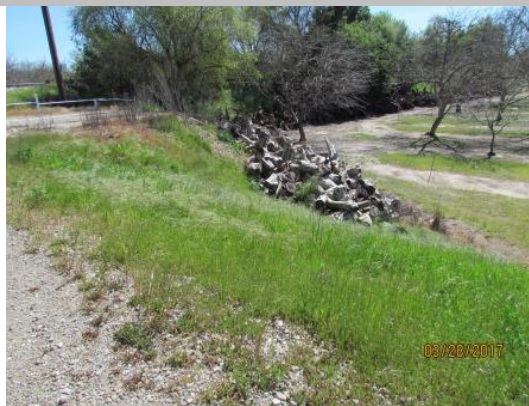
Photo 1 of 1 : SP_2017_RD1001_37_41_20170403_00053.jpg

LM Start	6.50	Rating **	M	Issue No.	41
LM End	6.50	Issue Type +	En	Location *	LS
Category	Earthen Levee			GPS Latitude/Longitude	
				Start	End
Item	Encroachments			38.983978 °	38.983978 °
				-121.488053 °	-121.488053 °
DWR ID	DWR_RD1001_03_s_2017_41				
Comment Code					
PR : Prunings					
Inspector Comment					
Remove pruning & stumps from levee slope and toe. Spring 2017.

View of large pruning's and stumps at levee slope and toe, Spring 2017.

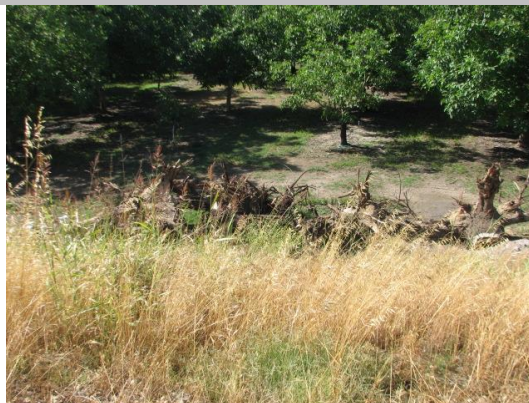
Photo 1 of 1 : SP_2017_RD1001_37_39_20170316_00028.jpg

LM Start	6.85	Rating **	M	Issue No.	39
LM End	6.85	Issue Type +	En	Location *	LS
Category	Earthen Levee			GPS Latitude/Longitude	
				Start	End
Item	Encroachments			38.983328 °	38.983328 °
				-121.494400 °	-121.494400 °
DWR ID	DWR_RD1001_03_s_2013_39				
Comment Code					
PR : Prunings					
Inspector Comment

Walnut stumps within the easement of the levee.

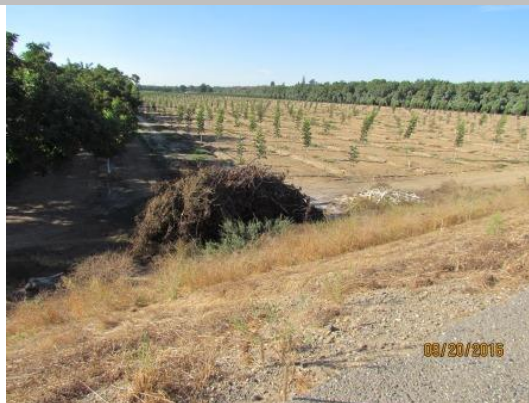
Photo 1 of 1 : SP_2017_RD1001_37_46_20170316_00032.jpg

LM Start	7.07	Rating **	M	Issue No.	46
LM End	7.07	Issue Type +	En	Location *	LS
Category	Earthen Levee			GPS Latitude/Longitude	
				Start	End
Item	Encroachments			38.982850 °	38.982850 °
				-121.498516 °	-121.498516 °
DWR ID	DWR_RD1001_03_s_2016_46				
Comment Code					
PR : Prunings					
Inspector Comment

Prunings at landside toe. Fall 2016.

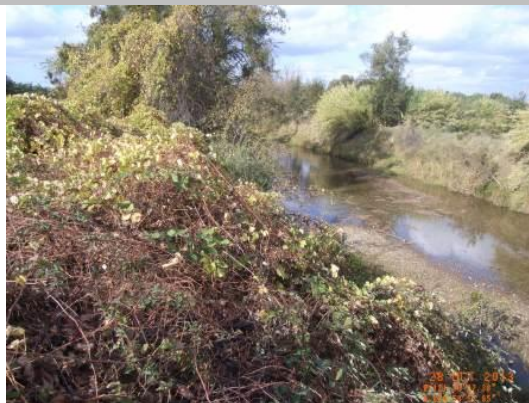
Photo 1 of 1 : SP_2017_RD1001_37_17_20170316_00013.jpg

LM Start	7.22	Rating **	M	Issue No.	17
LM End	7.31	Issue Type +	Ma	Location *	WS
Category	Supplemental			GPS Latitude/Longitude	
				Start	End
Item	2015 USACE Erosion Survey, DRAFT			38.982737 °	38.982572 °
				-121.501144 °	-121.502797 °
DWR ID	DWR_RD1001_03_s_2016_17				
Comment Code					
Inspector Comment					
2008 - Sandy/silty banks with rotational slab failures creating near vertical bank with pop-outs due to tree failures. Narrow berm. 2015: Last observed in 2013. [2015 Site ID: BER_5-7_L]

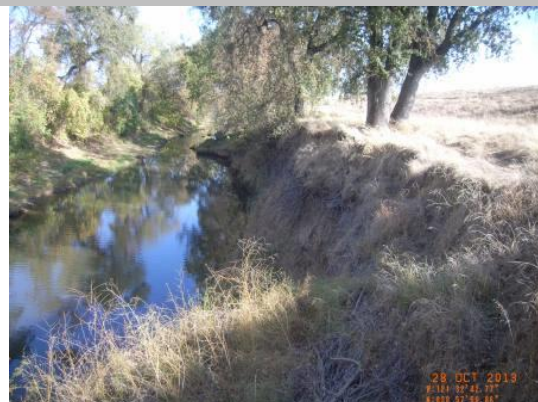
Photo 1 of 1 : SP_2017_RD1001_37_10_20170316_00010.jpg

LM Start	10.36	Rating **	M	Issue No.	10
LM End	10.40	Issue Type +	Ma	Location *	WS
Category	Supplemental			GPS Latitude/Longitude	
				Start	End
Item	2015 USACE Erosion Survey, DRAFT			38.964583 °	38.964010 °
				-121.544967 °	-121.545228 °
DWR ID	DWR_RD1001_03_s_2016_10				
Comment Code					
Inspector Comment					
2011 - Large section of bank has slumped off. RD has flagged and appears to be watching. 2012 - Slopes slightly steeper. 2013 - Minor new erosion observed. 2015: Last observed in 2013. [2015 Site ID: BER_2-5_L]

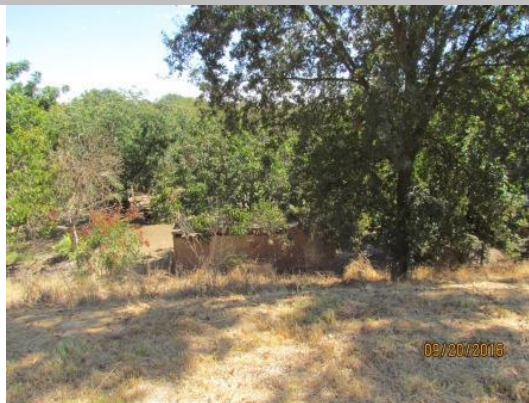
Photo 1 of 1 : SP_2017_RD1001_37_11_20170316_00011.jpg

LM Start	10.49	Rating **	M	Issue No.	11
LM End	10.49	Issue Type +	En	Location *	LS
Category	Earthen Levee			GPS Latitude/Longitude	
				Start	End
Item	Encroachments			38.962770 °	38.962770 °
				-121.545741 °	-121.545741 °
DWR ID	DWR_RD1001_03_f_2015_11				
Comment Code					
BU : Building					
Inspector Comment

View of building at the landside toe. Fall 2016.

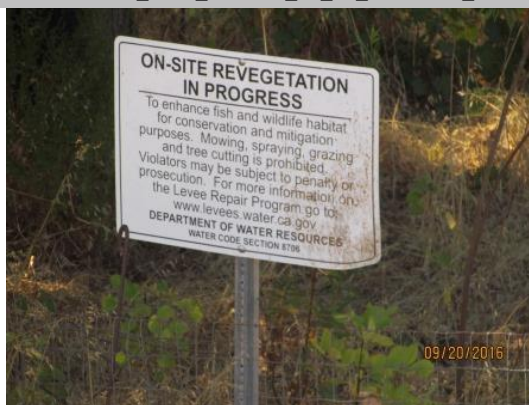
Photo 1 of 1 : SP_2017_RD1001_37_50_20170316_00034.jpg

LM Start	10.75	Rating **	A/W	Issue No.	50
LM End	10.96	Issue Type +	Ob	Location *	WS
Category	Earthen Levee			GPS Latitude/Longitude	
				Start	End
Item	Vegetation			38.959066 °	38.956212 °
				-121.546964 °	-121.547953 °
DWR ID	DWR_RD1001_03_f_2013_50				
Comment Code					
V8 : Environmental Requirements.					
Inspector Comment

Revegetation has been done in this area on the waterside. Visibility is minimal. Fall 2016.

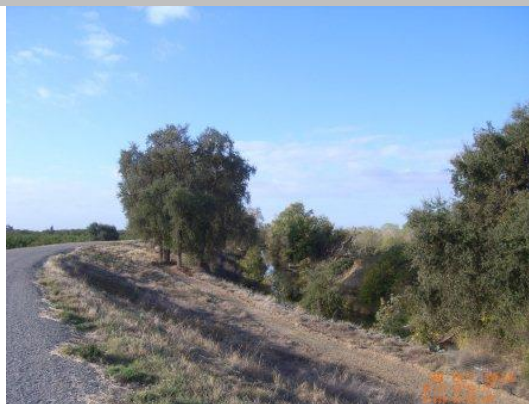
Photo 1 of 1 : SP_2017_RD1001_37_1_20170316_00001.jpg

LM Start	11.08	Rating **	M	Issue No.	1
LM End	11.16	Issue Type +	Ma	Location *	WS
Category	Supplemental			GPS Latitude/Longitude	
				Start	End
Item	2015 USACE Erosion Survey, DRAFT			38.955070 °	38.954227 °
				-121.549528 °	-121.550592 °
DWR ID	DWR_RD1001_03_s_2016_1				
Comment Code					
Inspector Comment					
2011 - Large slumped sections of bank. 2012 - Slopes slightly steeper. 2015: Last observed in 2013. [2015 Site ID: BER_1-9_L]
